Manhole Inspection Summary

Manhole # S23KK1002MH

Insp Date: **11/20/06 2:04 PM**

Location Address: **4300 BUCHANAN AVE**

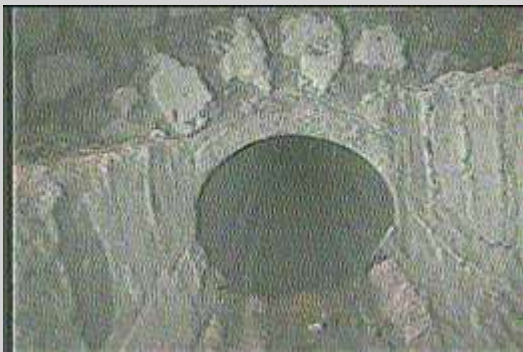
8 in. Circular Gravity Sewer Pipe Out @ 12 O'Clock

Rod and Bar (Angled)

Pipe Material: **Clay** ☐ Pipe Lined

Invert Depth: **11.78** (ft.) Flow Characteristics: **Slow**

Infiltration: **None** Pipe Seal Cond: **Unknown**

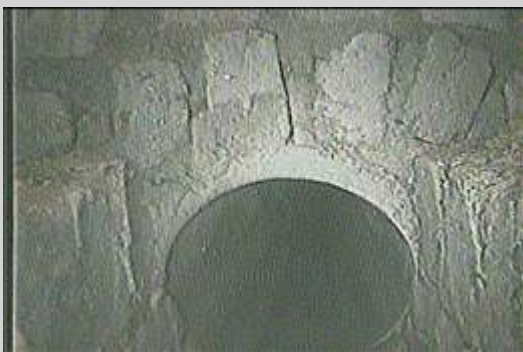
8 in. Circular Gravity Sewer

Rod and Bar (Angled)

Pipe Material: **Clay**

Infiltration: **None**
